NASA TECH BRIEF

Prevention of Cracking of Soldered Joints in Electronic Assemblies

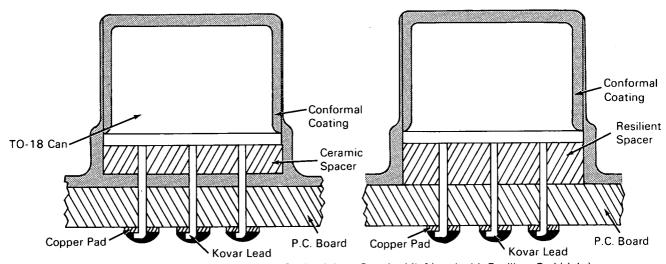
Transistor Configurations with Clinched Solder Joints: Standard (left) and with Resilient Pad (right)

Cracks have developed in soldered joints on printedcircuit boards in electronic assemblies at high altitudes. When in service such assemblies are subjected to much thermal cycling; the difference in coefficient of expansion between the boards and the components in the assemblies is reflected as force in the components' leads that causes stress and cracking.

Components' leads (see fig.) should be thoroughly cleaned, tinned, and freed of particles that may prevent adherence of solder—especially leads of encapsulated pulse transformers and modules that have seal-ant applied to the leads during the encapsulation. The conformal coating should be as thin as possible. There should be an air space between the conformal coating and the body of the component; in the absence of an air space there should be a resilient pad under the component. The pad should be such that there is little likelihood of the coating bridging under the component. Components should be "ruggedized" with fillets of the resilient material to reduce the likelihood of the conformal coating bridging under them.

Because of the primary cause of the cracking, the material of the conformal coating should be replaced by one having a lower coefficient of thermal expansion and a lower modulus of elasticity; such a material should be sought by research. A better material for resilient pads should be found.
